**TOWRANG STOCKADE  
ARCHAEOLOGICAL INVESTIGATION**

1987

**JH WINSTON-GREGSON  
ACCESS ARCHAEOLOGY PTY LTD**

Report to the Towrang Stockade Trust

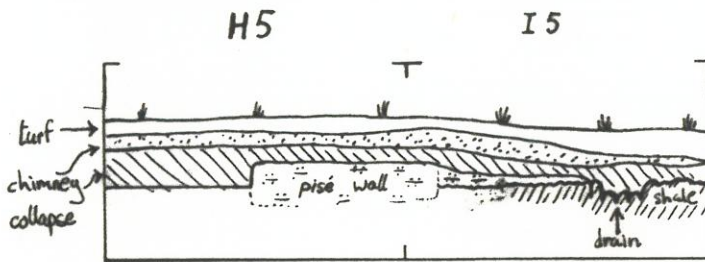
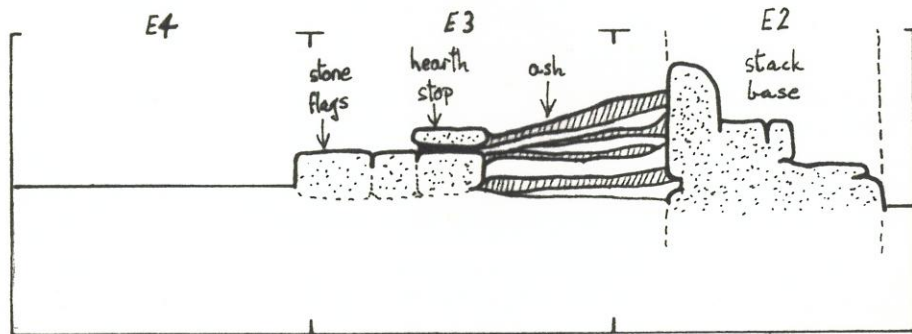
FIGURE 8  
Excavation in Section

west wall &  
dripline; north  
face A5

east wall & drain; north face H5 - I5

Hearth; west face E2 - E4;  
(ash has not been excavated from D3)

4.4 A transect of the mound between grid squares E2 and E4 immediately revealed a stone hearth (shown in section in Figure 8). The rear of the hearth lay beneath the turf; the sides and the front were covered by collapse. The flue had collapsed to the southeast in line with the prevailing wind. The hearth was built as a hollow rectangle: the front is a double row of flagstones about 250mm square, the sides and rear are undressed fieldstone. The front of the fire is defined by a line of stones mortared like a parapet to the rear of the flagstones. The mortar throughout the hearth is a fine soil mixed with burned shell and rock lime. The hollow within the hearth had been filled by ash which had accumulated to a depth of some 350mm. The ash was excavated in a narrow section leaving the bulk of the deposit. The ash contains fragments of bone, glass and clay pipestem.

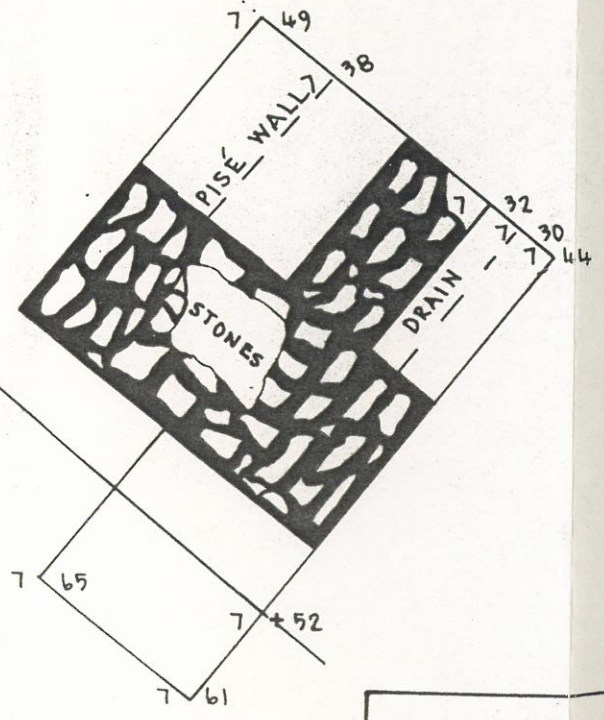
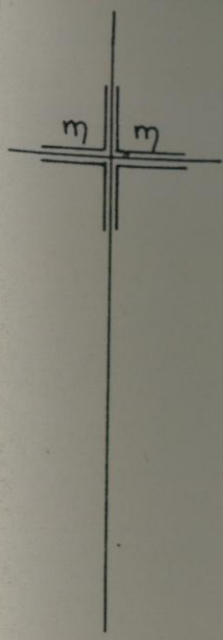
FIGURE 9  
 EDM survey of Mound 3  
 showing excavation  
 spot heights

TOWRANG STOCKADE DETAIL SURVEY  
 SOLDIERS HUT No. 3  
 PARISH - TOWRANG COUNTY - ARGYLE  
 LAND DISTRICT - GOULBURN SHIRE - MULWAREE  
 FILE No. GB 79R15    DRAWN GAF    DATUM - SEE SHEET 298A  
                                  SURVEYED GAF

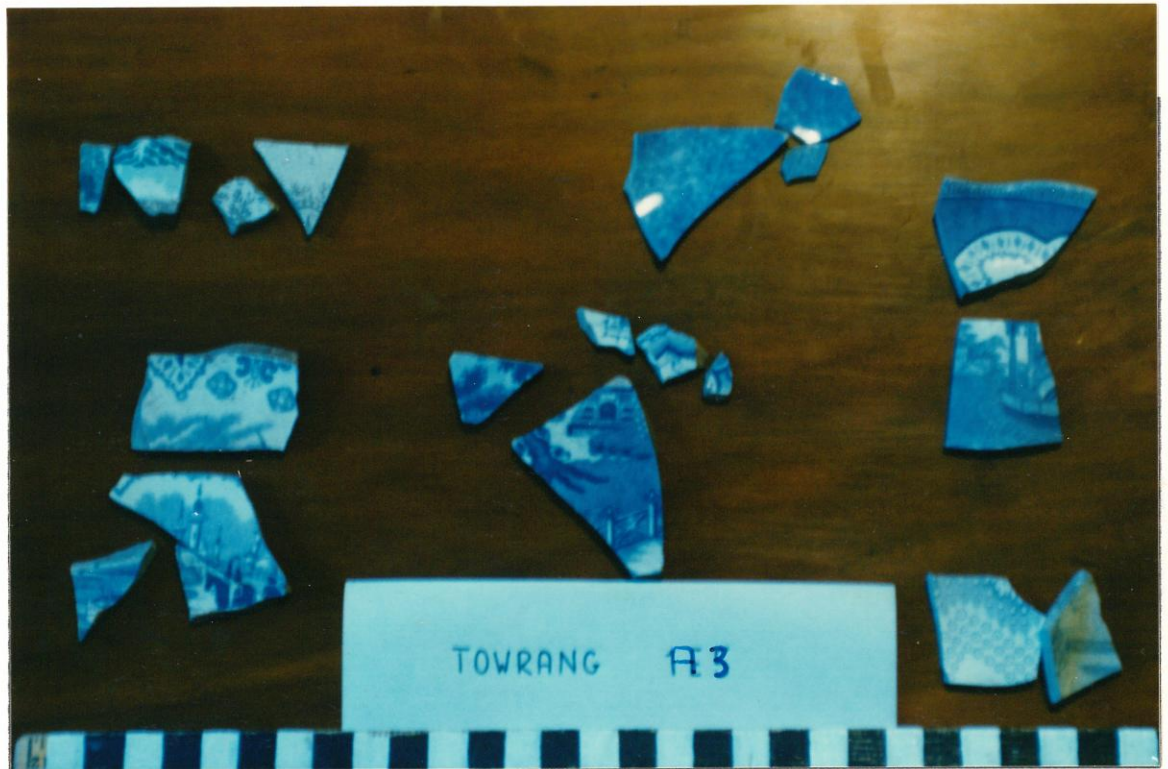
PLATE 1 : A representative sample of china from the dripline in grid square A3.  
10mm scale; photo jw-g 6.10.87

5.3 Mere numbers can give no hint of the interest of the artefacts. Plate 1 shows the china, more correctly the earthenware, found in the dripline in first grid square listed, grid A3. At least seven different patterns are represented. The large triangular shard near the centre of the photograph for example is a typical Spode Willow III as manufactured by Copeland & Garrett after they took over the Spode business in 1833. To

its left are shards of a neat drawing of two mounted janissaries, one with a quiver of arrows, before a city of minarets. Above are greenware, brownware and three shards of a delicate cloudy blue. How did such wares come to a chain gang stockade? In the same grid square was part of a case bottle (probably schnapps or gin) and farther along the dripline in grid square A6 was the stem of a clay tobacco pipe. The sense of domesticity is reinforced by a pin and a gilded wooden bead (grid square C2) and part of a uniform (?epaulet stiffener) in grid square D2. Elsewhere, a pearl button, a bone button and two steel buttons were found (grid squares A6, E3, H5). The small area excavated within the fireplace (grid square E3) produced at least two clay pipes (in sixteen pieces) and large amounts of bottle glass. It is difficult to picture a chain gang relaxing by the fire, chewing a chop (sheep vertebrae and ribs occur on the site) and puffing a cloud with a bottle of gin handy. The row of six hearths is a military cantonment, accommodation for the soldiers.

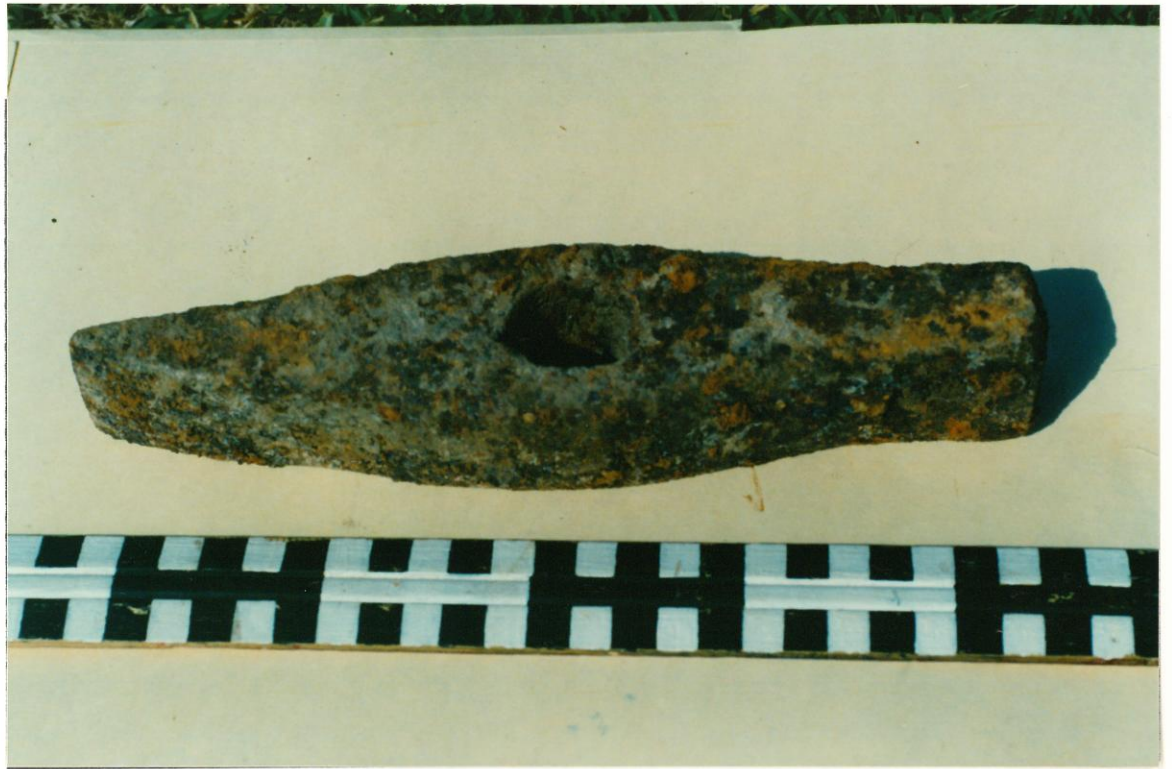
PLATE 2 : A hand forged pick head from the surface of true ground in  
grid square F2.  
10mm scale; photo jw-g 6.10.87

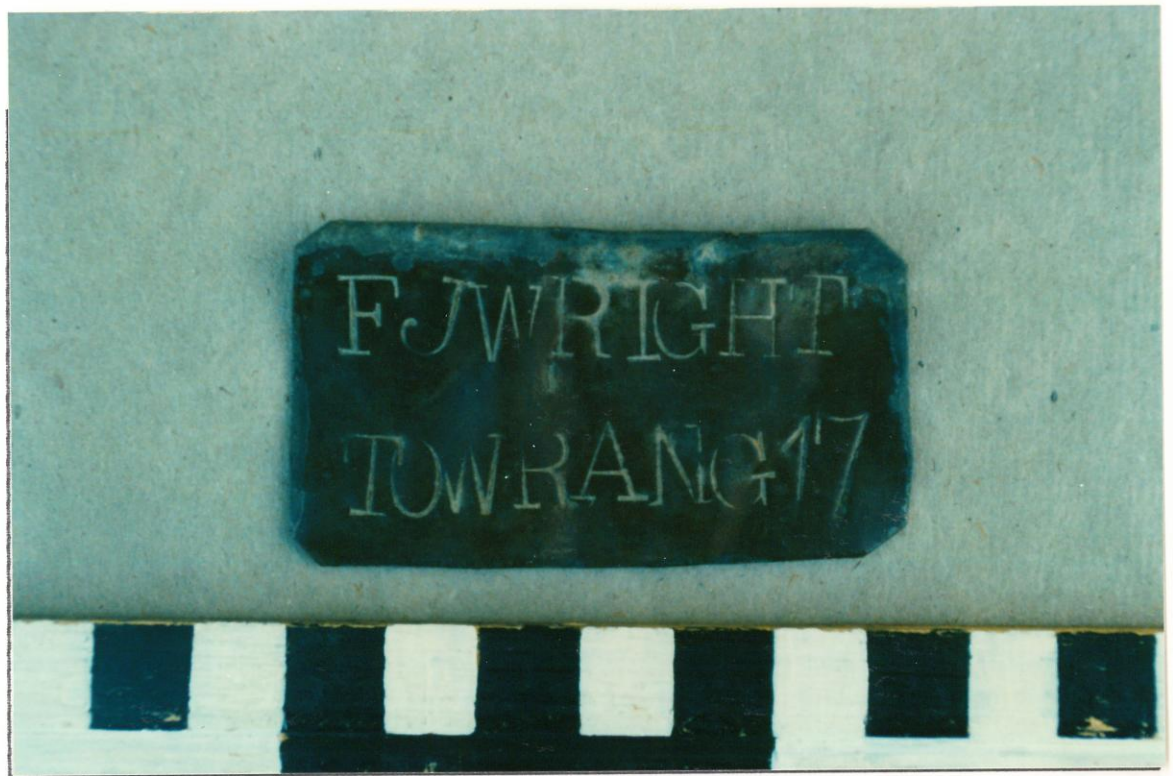
PLATE 3 : An identification plate; hand stamped on copper sheet, traces of solder on reverse. Unrecorded surface find by M. Stoddart. 10mm scale; photo jw-g 24.9.87

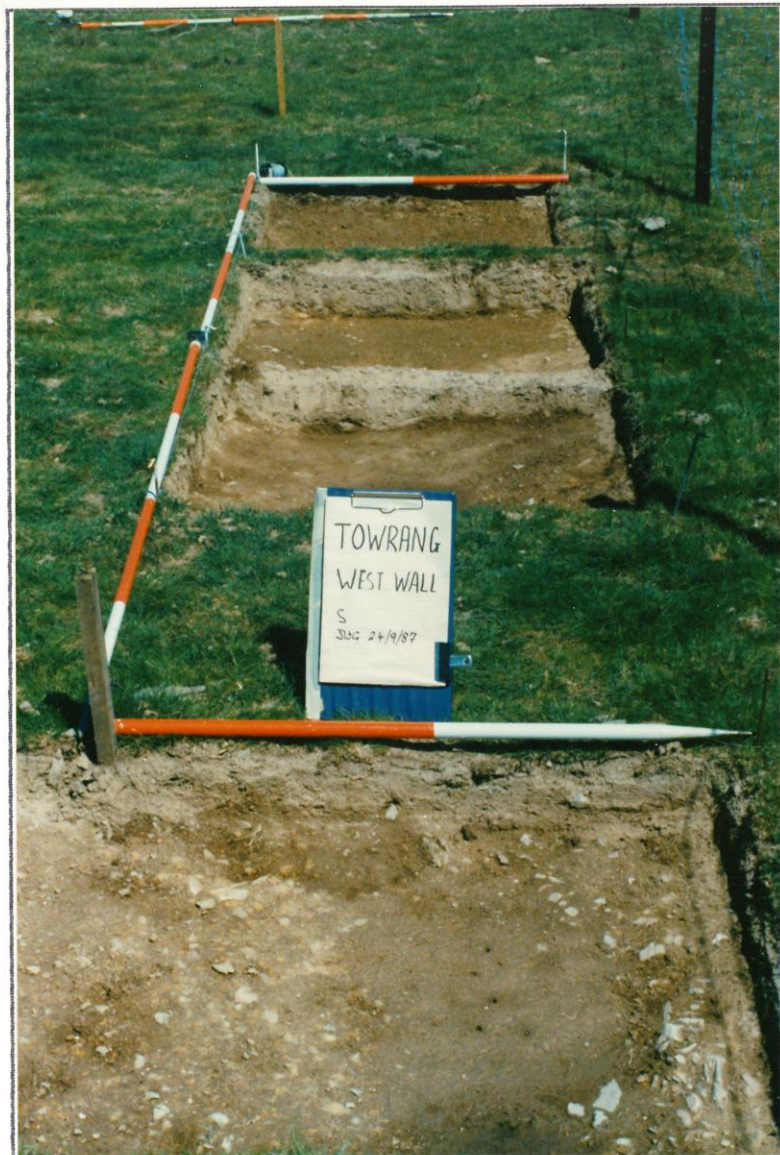
PLATE 4 : The dark dripline defines the west wall.  
500mm scale; photo jw-g 24.9.87

4.7 The wall base supported a pisé wall. The building was a rectangle approximately 3700mm by 7920mm external (say 12' x 26') with the hearth in the centre of the long north wall (see Figure 7). All walls were pisé. Except for the small retaining wall beside the hearth, the pisé was poured directly onto the ground without benefit of a slate footing or dampcourse. Presumably the sloping ground and the uplifted platform were considered sufficient to counteract ground damp. A dripline along the west and a similar feature chipped into the base shale at the east, define the melted pisé of the end walls and indicate a hipped roof. A single drain is cut right along the uphill side of the row of six mounds coincident -at Mound 3- with the beginning of the driplines of the end walls ie along the south wall parallel to the hearth wall.

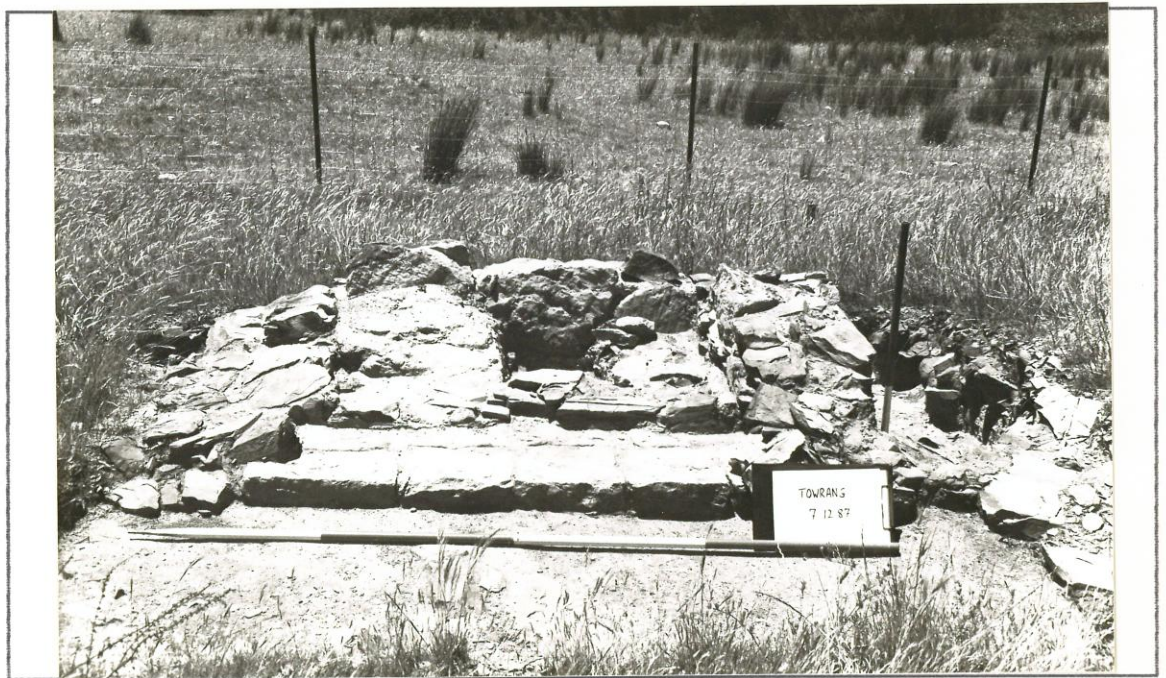
PLATE 5 : The excavated hearth of Mound 3. The ash has been sectioned in the right of the hearth. The structure remained stable during 3 months of exposure and has been backfilled only to the modern ground level. Detached stones have been stockpiled for re-attachment if required.  
500mm scale; photo jw-g 7.12.87

4.6 The hearth is an oblong built across the slope of the land. The hearth is large, 2040mm by 1720mm external (say 6'8" x 5'8") and 1240mm by 820mm internal (say 4' x 2'8"). A line of mortared rubble extends east from the hearth. The purpose of the rubble is to act both as a footing for the building wall and as a retainer since the interior of the building seems to have been built up as an earth platform to equate in height with the uphill exterior. The natural slope is pronounced so that the base of the hearth exterior downhill is some 300mm lower than the base of the uphill flagstones. The hearth exterior was rendered and limewashed and the same treatment apparently extended over the rubble wall base.
